# Uniform Mitigation Verification Inspection Form

| Inspection Date: <b>03-27-2020</b> | | |
| Owner Name: <b>Bermuda Greens Condominium Association</b> | | Contact Person: Owner or Board Member |
| Address: <b>13055 Castle Harbour Drive</b> | | Home Phone: |

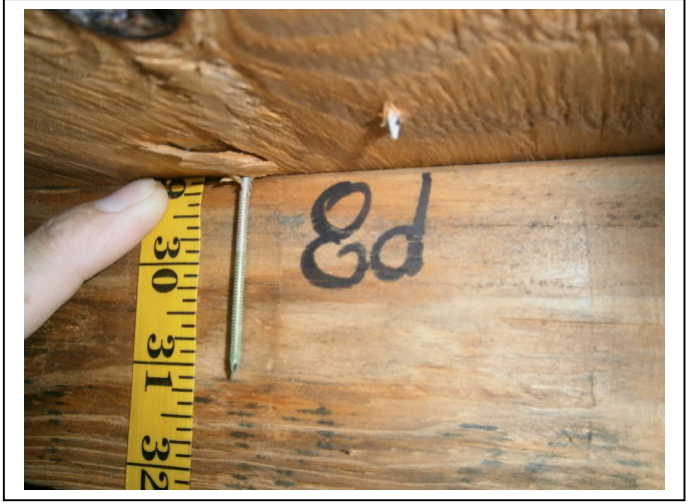
ROOF DECK ATTACHMENT – 8d ring shank  
nails added in 2014

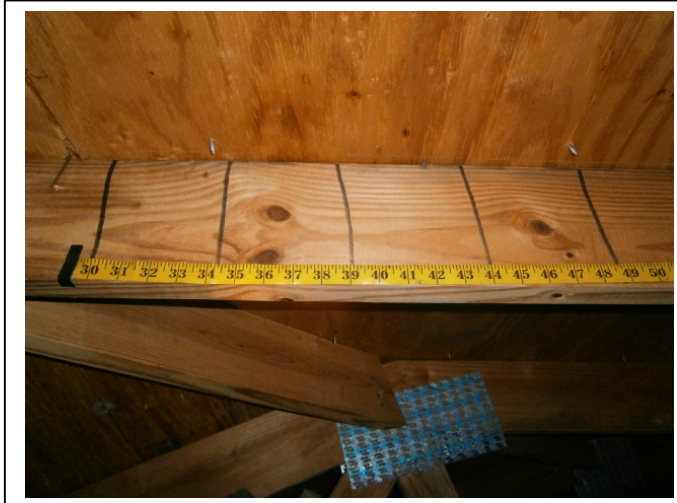
ROOF DECK ATTACHMENT – 8d nails within  
6 inches along the edge

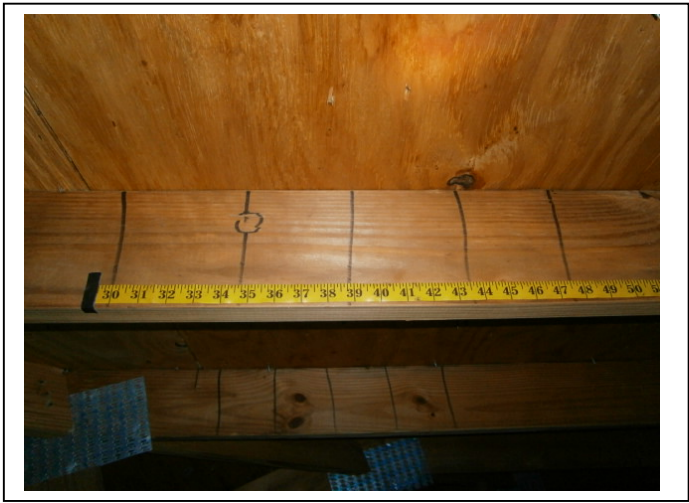
- ☒ C. Plywood/OSB roof sheathing with a minimum thickness of 7/16" inch attached to the roof truss/rafter (spaced a maximum of 24" inches o.c.) by 8d common nails spaced a maximum of 6" inches in the field. -OR- Dimensional lumber/Tongue & Groove decking with a minimum of 2 nails per board (or 1 nail per board if each board is equal to or less than 6 inches in width). -OR- Any system of screws, nails, adhesives, other deck fastening system or truss/rafter spacing that is shown to have an equivalent

ROOF DECK ATTACHMENT – 8d nails within  
6 inches in the field

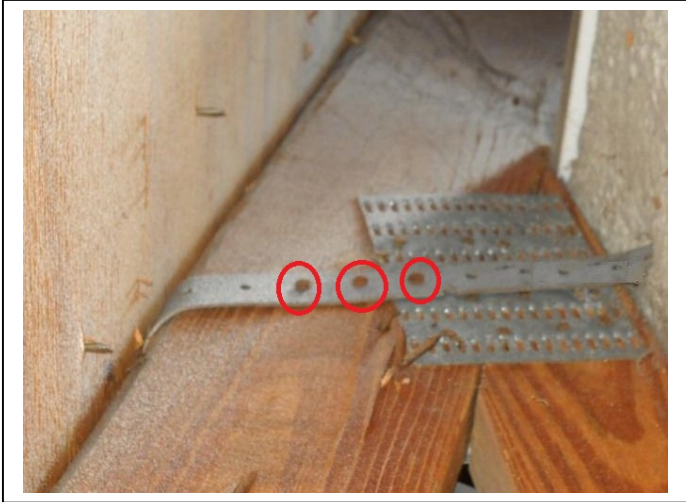
- ☒ C. Single Wraps
  - Metal connectors consisting of a single strap that wraps over the top of the truss/rafter and is secured with a minimum of 2 nails on the front side and a minimum of 1 nail on the opposing side.

ROOF TO WALL ATTACHMENT – Properly installed Single Wraps

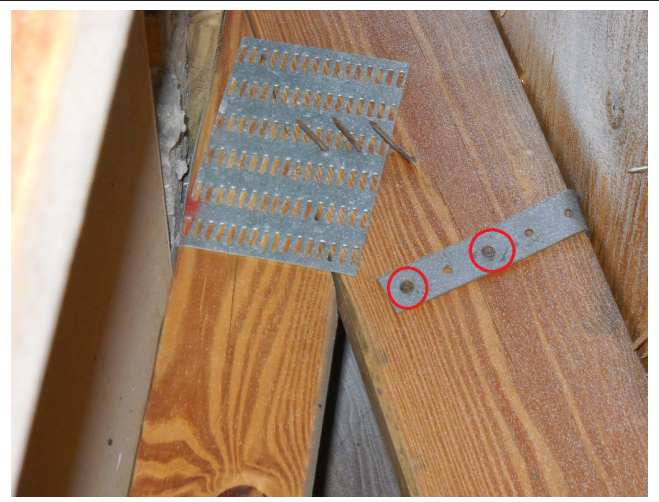
ROOF TO WALL ATTACHMENT – Properly installed Single Wraps

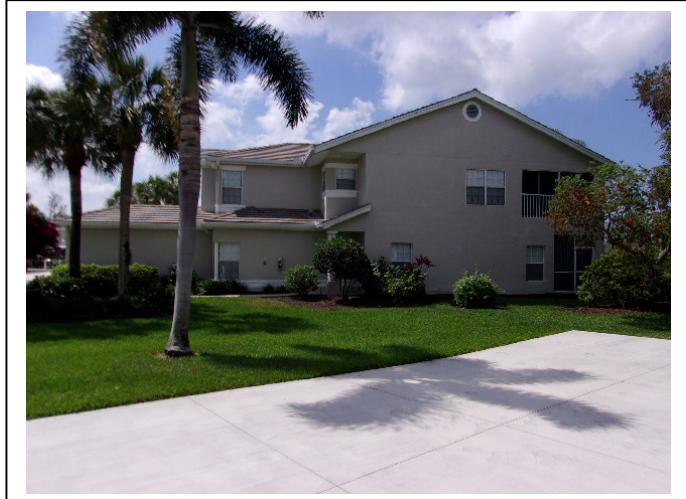
- ☐ A. Hip Roof      Hip roof with no other roof shapes greater than 10% of the total roof system perimeter.  
Total length of non-hip features: \_\_\_\_\_ feet; Total roof system perimeter: \_\_\_\_\_ feet
- ☐ B. Flat Roof      Roof on a building with 5 or more units where at least 90% of the main roof area has a roof slope of less than 2:12. Roof area with slope less than 2:12 \_\_\_\_\_ sq ft; Total roof area \_\_\_\_\_ sq ft
- ☒ C. Other Roof      Any roof that does not qualify as either (A) or (B) above.

ROOF GEOMETRY – Gable / Other Roof Shape

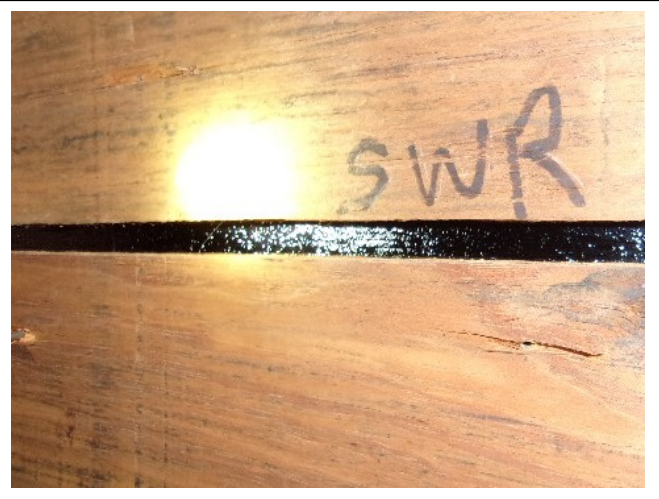
- ☒ A. SWR (also called Sealed Roof Deck) Self-adhering polymer modified-bitumen roofing underlayment applied directly to the sheathing or foam adhesive SWR barrier (not foamed-on insulation) applied as a supplemental means to protect the dwelling from water intrusion in the event of roof covering loss.
- ☐ B. No SWR.
- ☐ C. Unknown or undetermined.

SECONDARY WATER BARRIER – A Peel & Stick adhesive polymer SWR Barrier was installed in 2014 when the covering system was replaced

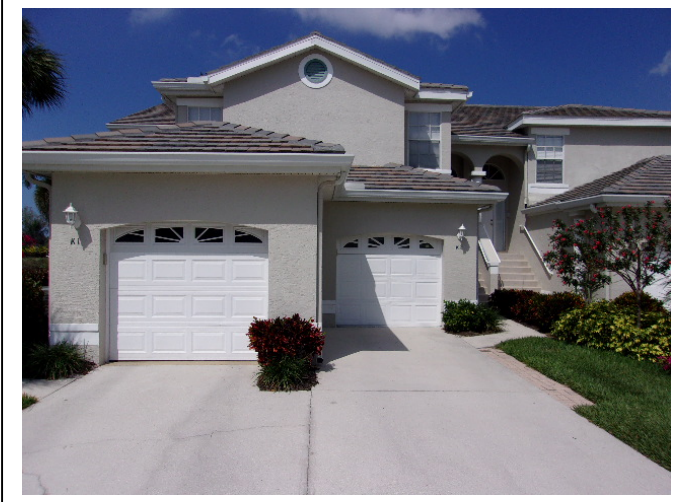
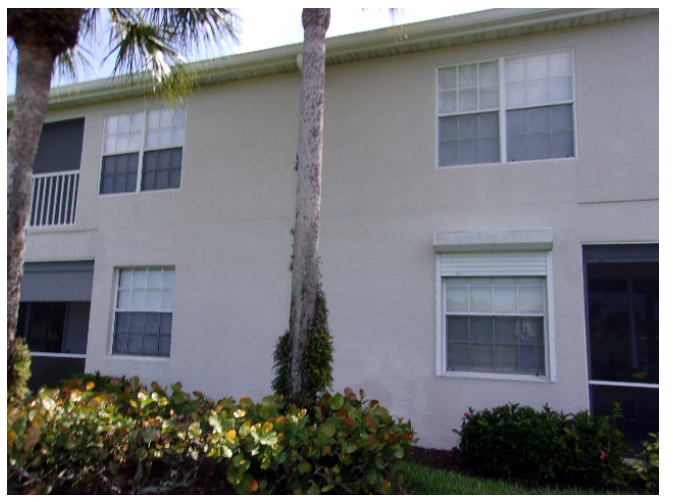
| Opening Protection Level Chart<br>Place an "X" in each row to identify all forms of protection in use for each opening type. Check only one answer below (A thru X), based on the weakest form of protection (lowest row) for any of the Glazed openings and indicate the weakest form of protection (lowest row) for Non-Glazed openings. | | Glazed Openings | | | | Non-Glazed Openings | |
|---|---|---|---|---|---|---|---|
| X | No Windborne Debris Protection | X | X | | | X | |

OPENING PROTECTION – Although some unit owners have installed wind-borne debris protection devices, others have not, leaving some of the openings (entry doors, glazed garage doors, window units & sliding doors) unprotected
