# Uniform Mitigation Verification Inspection Form

| Inspection Date: <b>03-27-2020</b> | | |
| Owner Name: <b>Bermuda Greens Condominium Association</b> | | Contact Person: Owner or Board Member |
| Address: <b>13140 Hamilton Harbour Drive</b> | | Home Phone: |

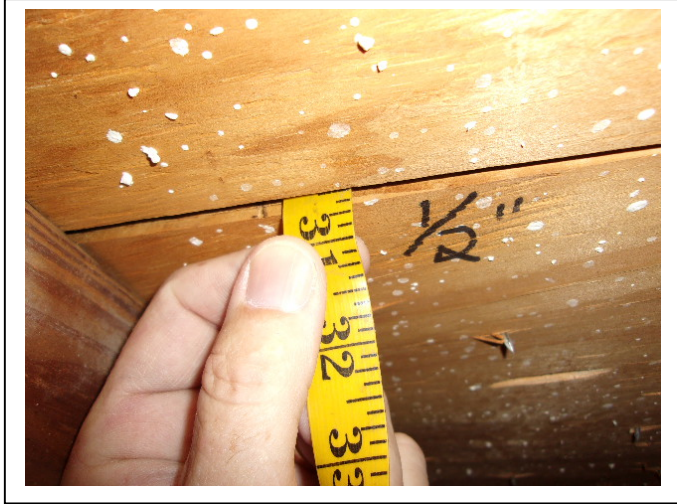
ROOF DECK THICKNESS – 15/32 to 1/2 inch  
plywood

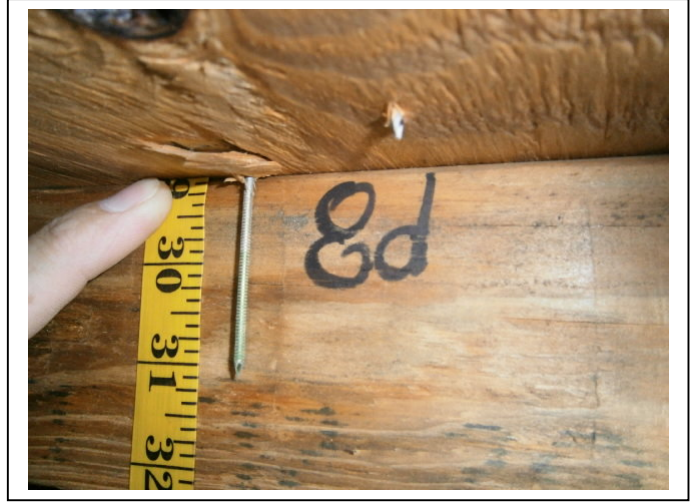
ROOF DECK ATTACHMENT – 8d ring shank  
nails added in 2014

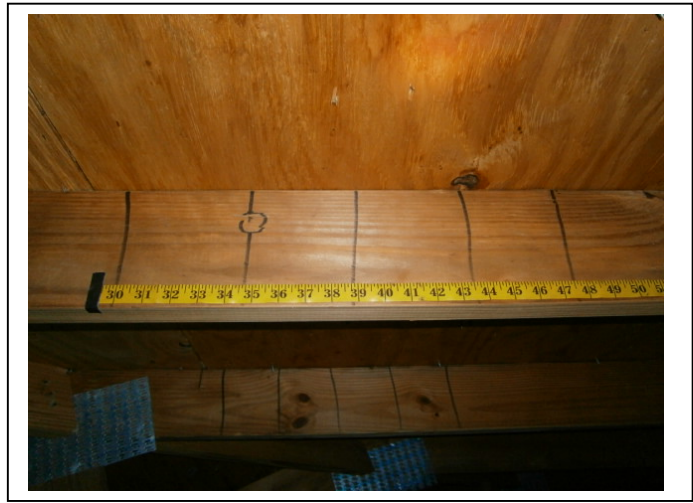
- ☒ C. Plywood/OSB roof sheathing with a minimum thickness of 7/16" inch attached to the roof truss/rafter (spaced a maximum of 24" inches o.c.) by 8d common nails spaced a maximum of 6" inches in the field. -OR- Dimensional lumber/Tongue & Groove decking with a minimum of 2 nails per board (or 1 nail per board if each board is equal to or less than 6 inches in width). -OR- Any system of screws, nails, adhesives, other deck fastening system or truss/rafter spacing that is shown to have an equivalent

ROOF DECK ATTACHMENT – 8d nails within  
6 inches in the field

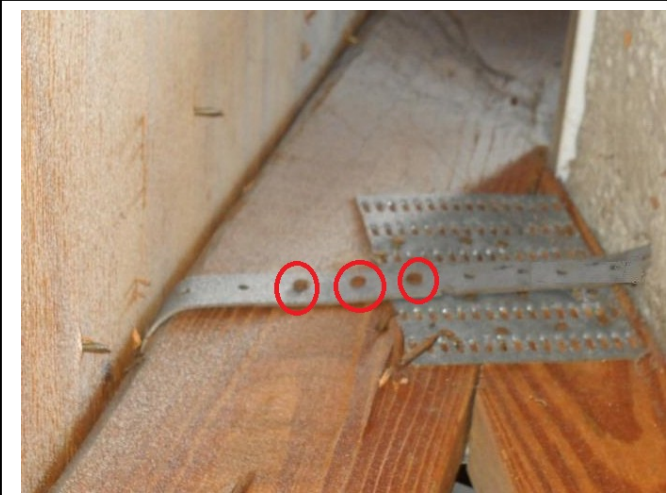
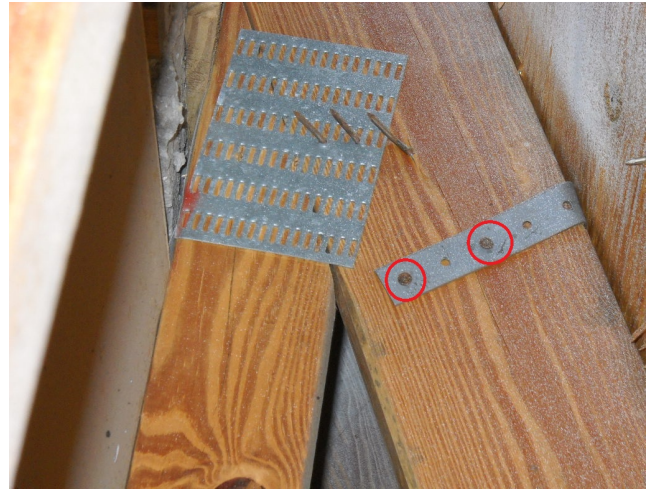
- ☒ C. Single Wraps
  - Metal connectors consisting of a single strap that wraps over the top of the truss/rafter and is secured with a minimum of 2 nails on the front side and a minimum of 1 nail on the opposing side.

ROOF TO WALL ATTACHMENT – Properly installed Single Wraps

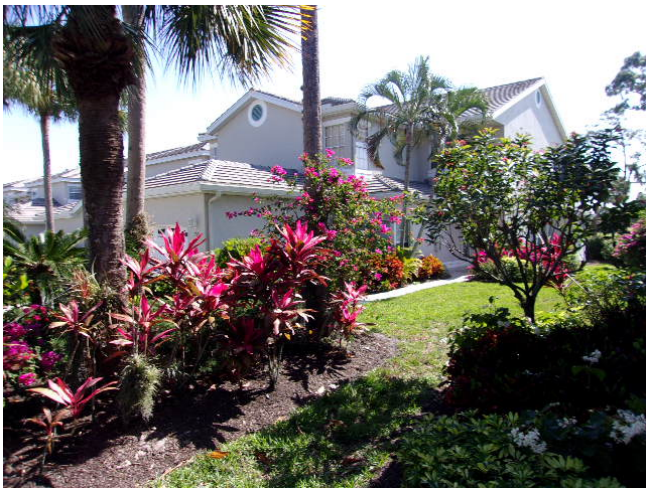
ROOF GEOMETRY – Gable / Other Roof Shape

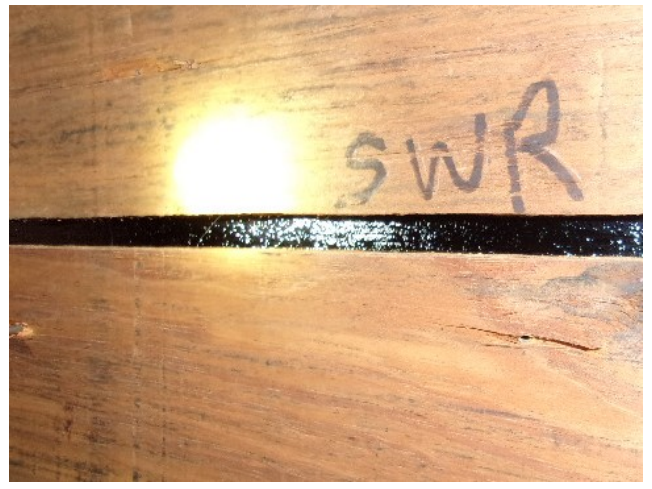
SECONDARY WATER BARRIER – A Peel & Stick adhesive polymer SWR Barrier was installed in 2014 when the covering system was replaced

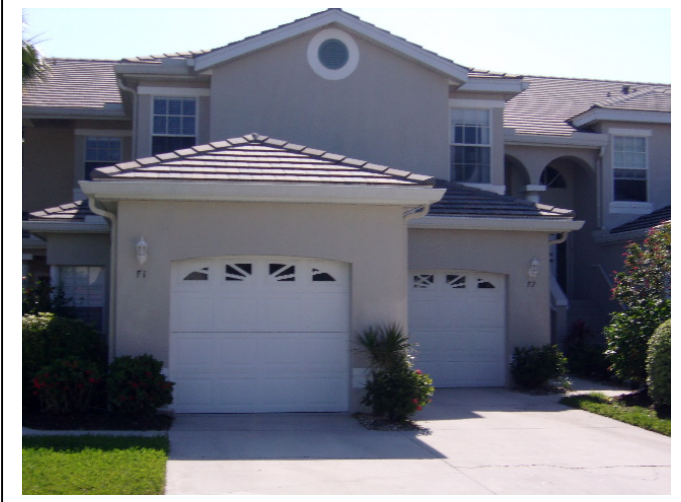
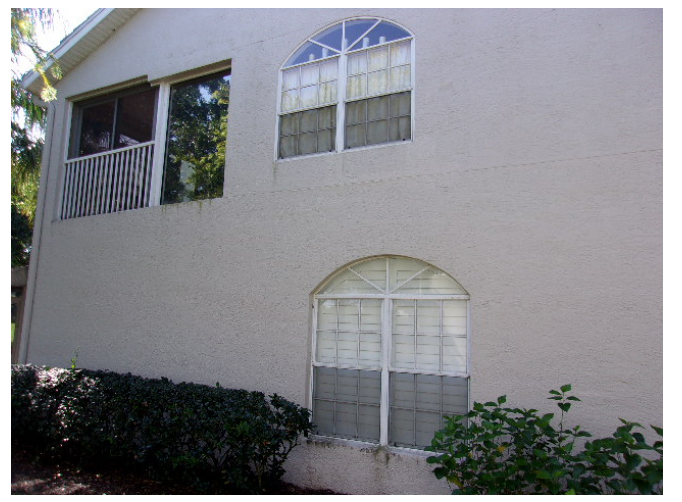
OPENING PROTECTION – Although some unit owners have installed wind-borne debris protection devices, others have not, leaving some of the openings (entry doors, glazed garage doors, window units & sliding doors) unprotected
